ONR Technical Report 18

Morphological Changes in Polymer Electrolyte Cells

M.Z.A. Munshi, & B.B. Owens

May 1988

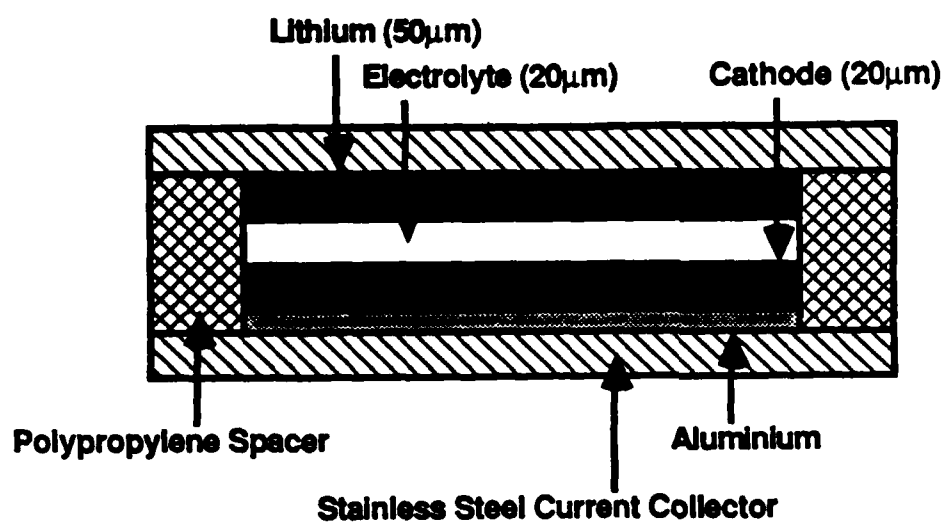
Figure 1. Schematic of the polymer electrolyte cell.

Cells were assembled in the dry room as shown in Figure 1. The geometrical surface area of the electrolyte, cathode and lithium was effectively  $6.4 \text{ cm}^2$ . Polypropylene spacers were used to separate the two electrodes. Two layers of electrolyte were employed in each cell. Each cell was sandwiched between two stainless steel plate current collectors and a clamping system was used to maintain a constant pressure and electrode gap. The cells were cycled in an oven at  $100^\circ\text{C}$  in the glove box.

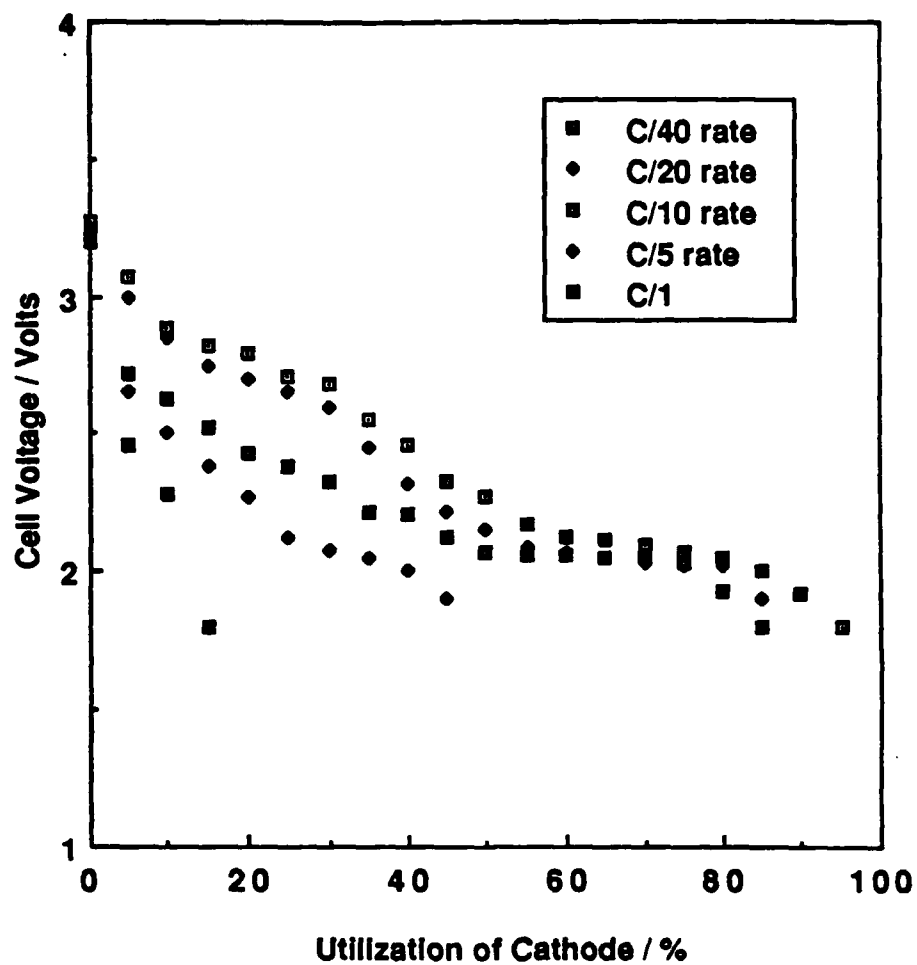
Figure 2. Typical family of discharge curves at 100°C.

Figure 2 shows typical families of discharge curves for a 13 mAh cell at various rates from the 40h (C/40) rate to the 1h (C) rate, operating at a temperature of 100°C [10]. The cut-off voltage was +1.8V. The discharge curves have several distinct plateaus and these are thought to be characteristic of the change in the oxidation state of the  $V_6O_{13}$  cathode. Another factor that may give rise to these plateaus is the apparent continuous increase in the IR drop of the cell during discharge [12]. It is believed that this increase originates not only from changes taking place at the cathode, but also due to a change in the electrolyte resistivity as a result of counter ion transport to the anode. During recharge there is a loss in capacity compared to the initial discharge.

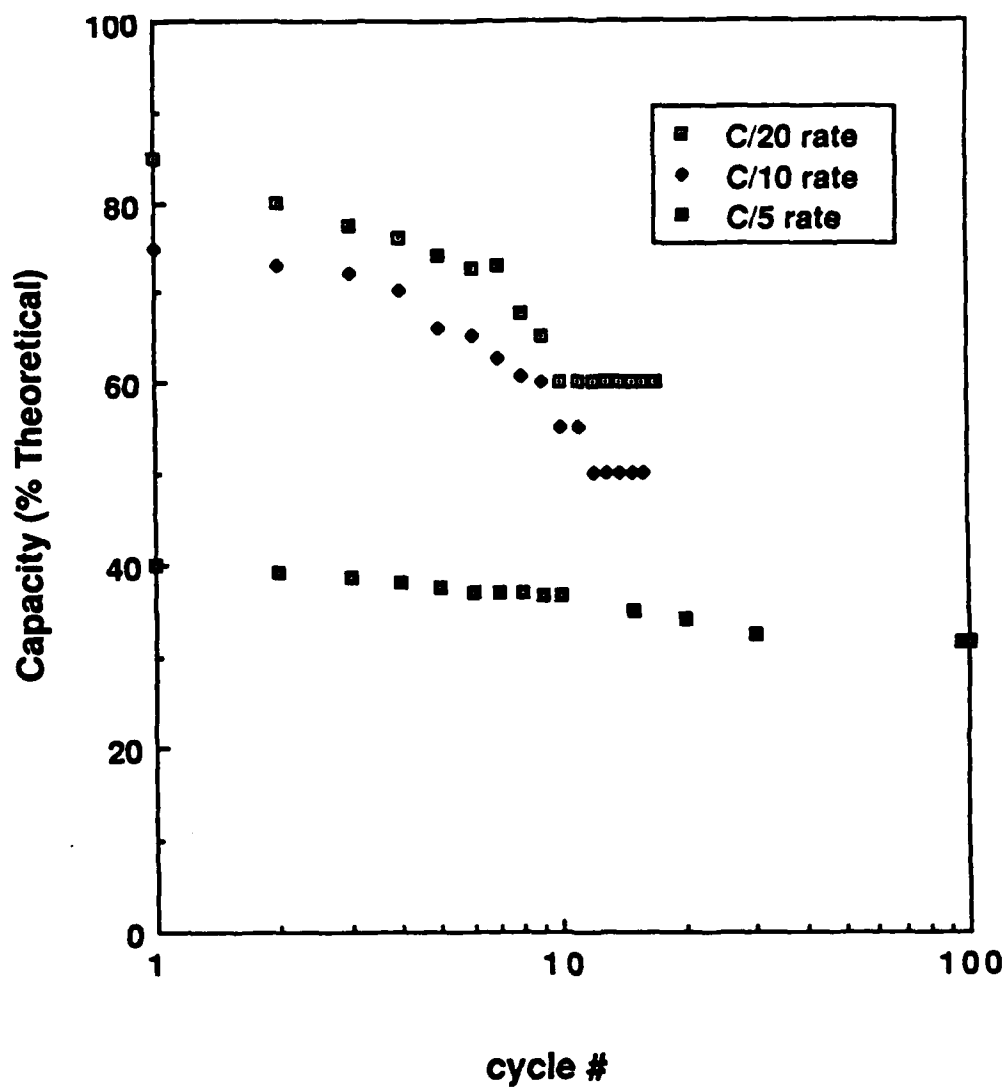
Figure 3. Plot of capacity versus cycle # for cells at 100°C.

A plot of the theoretical capacity versus the number of cycles is shown in Figure 3 [12]. At low rates, the initial capacity is considerably greater than at high rates, as expected. However, the decline in capacity is much faster at the lower rates of discharge than at the higher rate, with greater stabilization in capacity occurring at the C/5 rate. These results are consistent with the work of Hooper and North [8]. At the C/5 rate, a hundred cycles were obtained with greater than 75% of the initial utilization of  $V_6O_{13}$  being maintained at cycle number 100. From cycle number 35 to cycle number 100 the coulombic efficiency was almost 100% with very little reduction in the capacity.

The above results suggest that the structures of the lithium, electrolyte and cathode are consistent with one another and with the cycling data. The study vividly demonstrates that during cycling, the cell material structure actually improves. If this is so, the cell should give several hundred cycles without appreciable degradation of the electrolyte or the active materials. This is evident to some extent in the cell cycled 100 times. After cycle number 34, the capacity decrease is almost negligible.
